HAZARD ALERT

TANDEM LIFT WEIGHT LIMITS CANNOT BE IGNORED

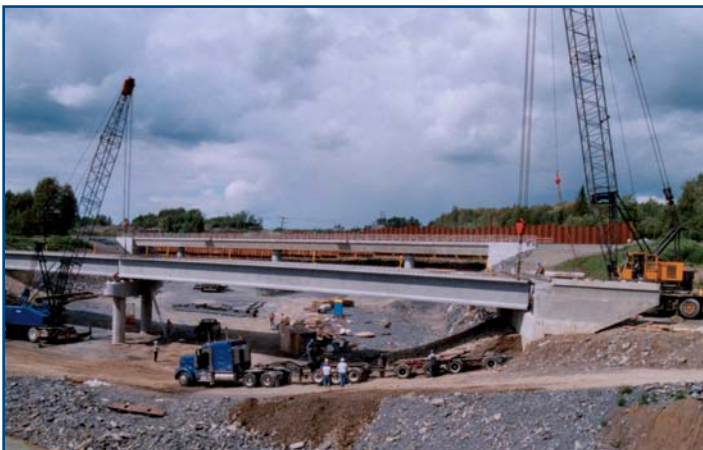
Considerable damage and expense was incurred, and two highway construction workers were injured, during a complex tandem lift involving two cranes. A 90-foot lattice boom collapsed when the work radius and weight capacity of a crane to lift a 40-foot concrete beam was miscalculated. The cause of the accident was failure to stay within the crane's safe operating limits.

One side of the beam had already been raised when the operator of the second crane was instructed to raise his end of the concrete beam. Movement of the load caused the back end of the first crane carrier to rise about 3.6 m in the air. The beam was quickly lowered to the ground causing the lattice boom to strike the capbeam. This resulted in the crane carrier dropping back on its wheels, thereby creating a spring action in the boom. The boom fell backwards, hit the crane cab and collapsed onto a nearby truck. Five workers in the immediate vicinity could have suffered severe or fatal injuries.

An investigation concluded that proper planning and procedure was not in place at the time of the accident.

1. Lifts involving two or more cranes are complex operations requiring considerable skill and planning. As a result, multiple crane lifts (or tandem lifts) must be planned and carried out under the supervision of a competent person.

2. The competent person must develop and communicate a detailed lift plan which contains, but is not limited to, the following:
 - Crane positioning
 - Rigging

- Lift sequence
 - Movement of the load (the longest radius of each crane for the complete operation must be measured exactly)
 - Load weight and distribution

- Boom lengths and angles
 - Environmental considerations
 - Rated capacity of each crane for the whole operation (no crane should be loaded to more than 75% of its net capacity).

3. Boom angle indicators are required on all mobile cranes, but they must not be relied upon for accuracy in critical lifts such as tandem lifts. A Load Moment Indicator (LMI) gives an accurate angle as well as loading throughout the lift.

4. According to section 207(2)(e) of Regulation 91-191 under the Occupational Health and Safety Act, an employer must ensure that a mobile crane is operated as per CSA Z150-98 "Safety Code for Mobile Cranes". The standard contains many provisions such as those outlined above that must be followed when operating a crane in the province of New Brunswick. To obtain a copy of the standard, contact the Canadian Standards Association.
